Hazards Associated with Strand Restraint Devices in Manufacturing  
Prestressed Concrete Beams

Safety and Health Information Bulletin

SHIB 06-02-2004

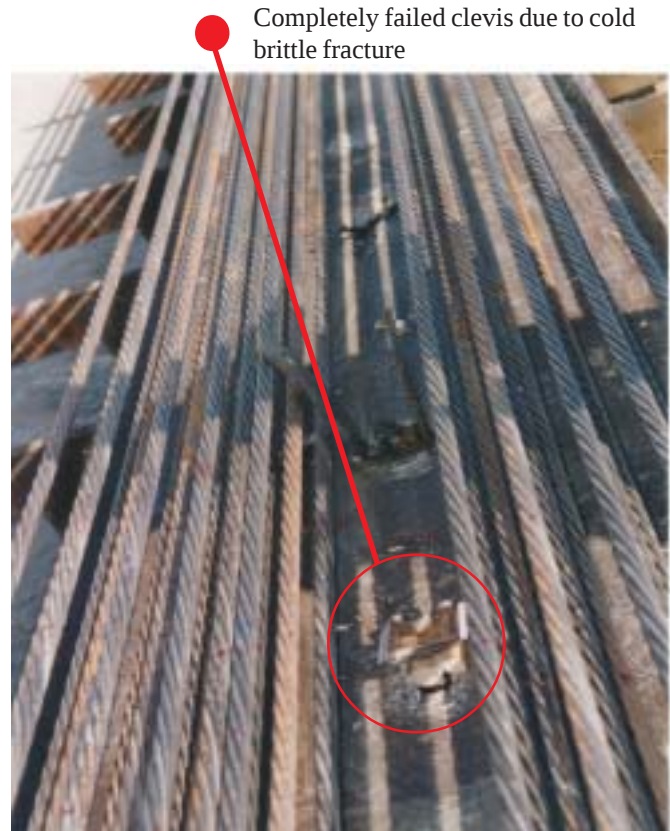
An employee was in the process of removing the shims when the two outside strand restraint devices (holding four cables) in one section failed. This, in turn, caused the two inside restraint devices (holding two cables) in the same section also to fail, but in a different manner. The two outside restraint devices failed at their base due to tensile and bending stresses. On the two inside devices the bolts holding the cables failed, possibly due to bending stresses. When the drape strand cables released, a cable struck an employee in the head, resulting in a fatality. Because of cold weather conditions at the time of the accident, cold brittle metal fracture also contributed to the restraint device (clevis) failure.

The non-pivoting design of the restraint devices also imposed bending (flexural) stresses in the base of the devices, which further contributed to the failure of the devices.

Figure #1  
Failed clevises (restraint devices)

1. Ensure that strand restraint devices are engineered and designed to withstand the forces and moments imposed by the drape strands and to prevent cold brittle fracture

during cold weather. Several manufacturers make strand restraint devices that have been so engineered and designed. Pivoting or swiveling-type restraint devices can be used to prevent the bending (flexural) stresses in the base of the restraint device.

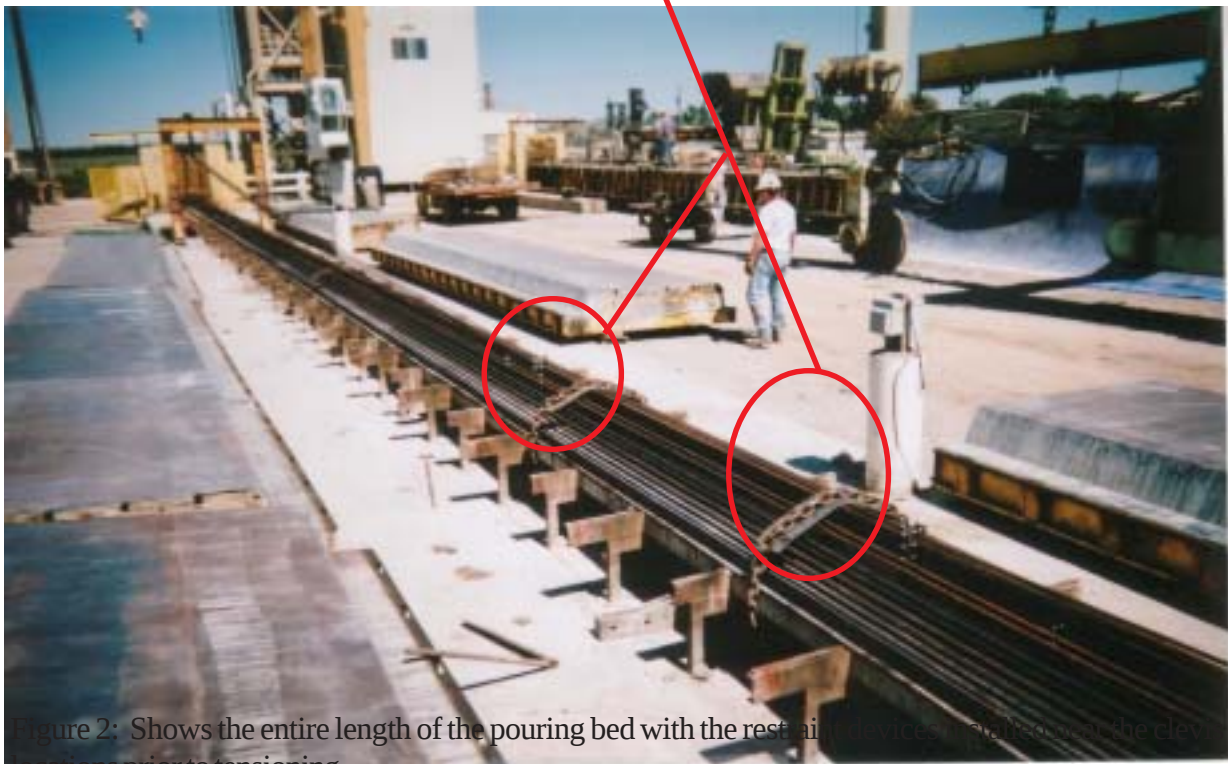
Figure 2: Shows the entire length of the pouring bed with the restaining devices installed at the elevation locations prior to tensioning

Figures 2 and 3 show changes made to the process.

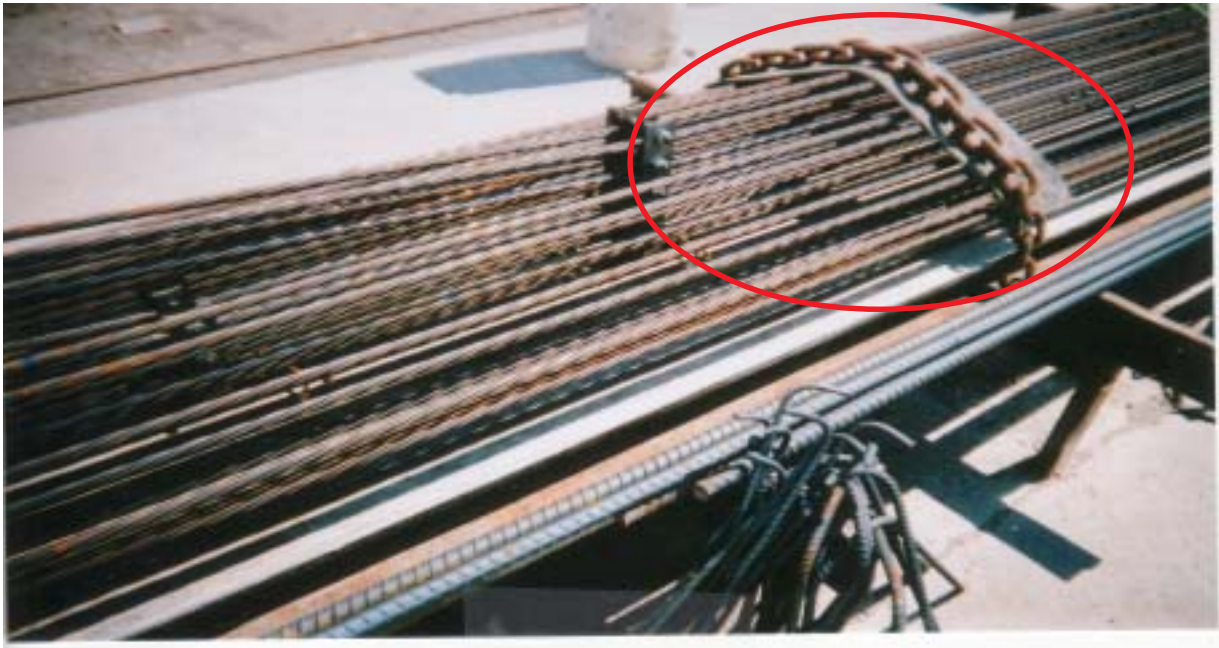
Figure 3. Close-up View of Restraint Device.

Figure 3: Shows a restraint device installed to prevent cables from releasing in the event of clevis failure during tensioning.
