## Hazard of Potential Sidewalk Grate System Failure

### Safety and Health Information Bulletin

SHIB 12-30-2004

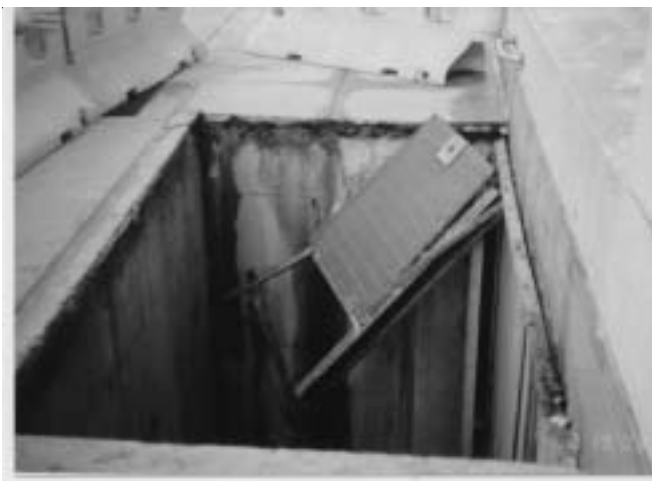
Figure 1.

The Occupational Safety and Health Administration's (OSHA's) Braintree, Massachusetts Area Office investigated a fatal accident where a skid-steer loader used to clear snow from sidewalks plunged into a vault when a metal grate (Figure 1) covering the vault failed.

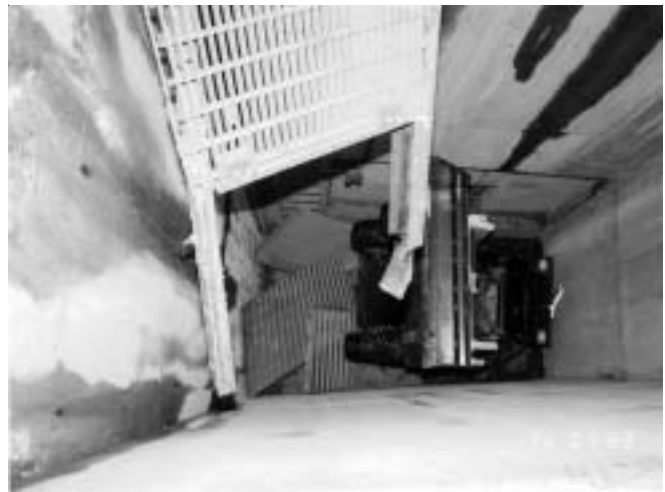
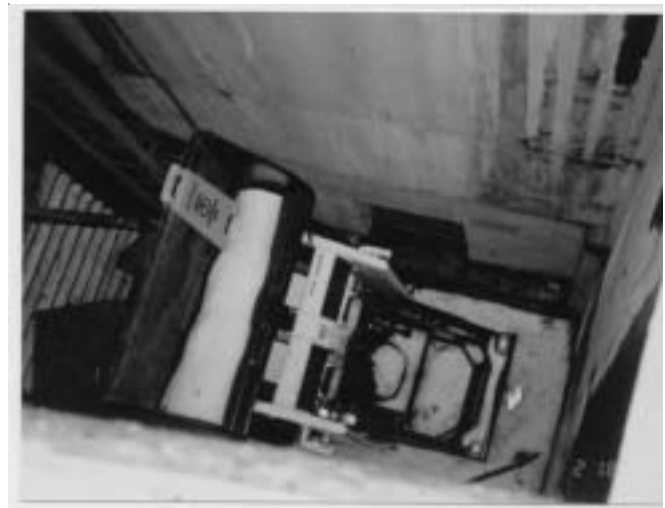
Figure 2.

Different crew members drove the skid-steer loader over the grate on the evening of the accident. When the victim drove over the grate, the grate system failed. The bolts attaching the angle iron to the concrete later were found to be corroded. The load caused the bolts to fail, pulling the angle iron away from the concrete and permitting the grates and the skid-steer loader to drop approximately 20 feet (Figures 2 & 3). The employee died about an hour after the accident.

The support system for the sidewalk grate at the Boston-area hospital was not built with redundant supporting mechanisms and the entire grate system was not designed for the concentrated load of heavy equipment such as skid-steer loaders, forklifts or other vehicles. The steel and concrete interface was subject to corrosion from weather and salt. The bolts that anchored the angle iron into the concrete wall were not visible during regular inspections, so the extent of the corrosion could not be detected.

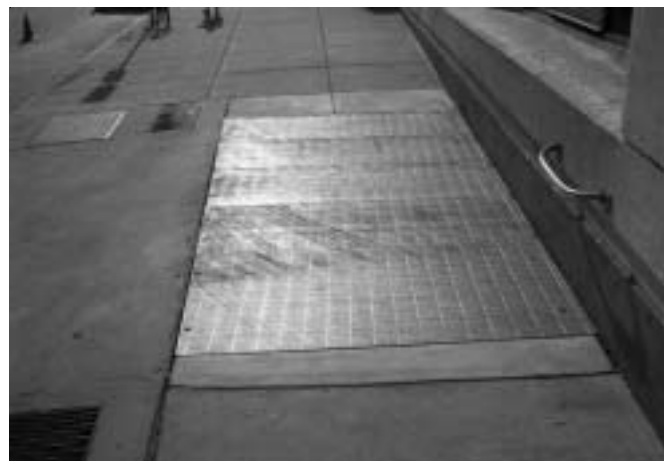
The employer installed a new grate system with sufficient capacity to support heavy equipment (Figure 4) after the accident.

Figure 4.  
New Grate System

- When building new vaults, consult with a professional structural engineer in designing a concrete shelf system for the angle irons to rest on and be bolted onto, and certify the load capacity of the grate system.
