Guardrail System for Tunnel Form Stripping Platform

Safety and Health Information Bulletin

SHIB 08-08-2006

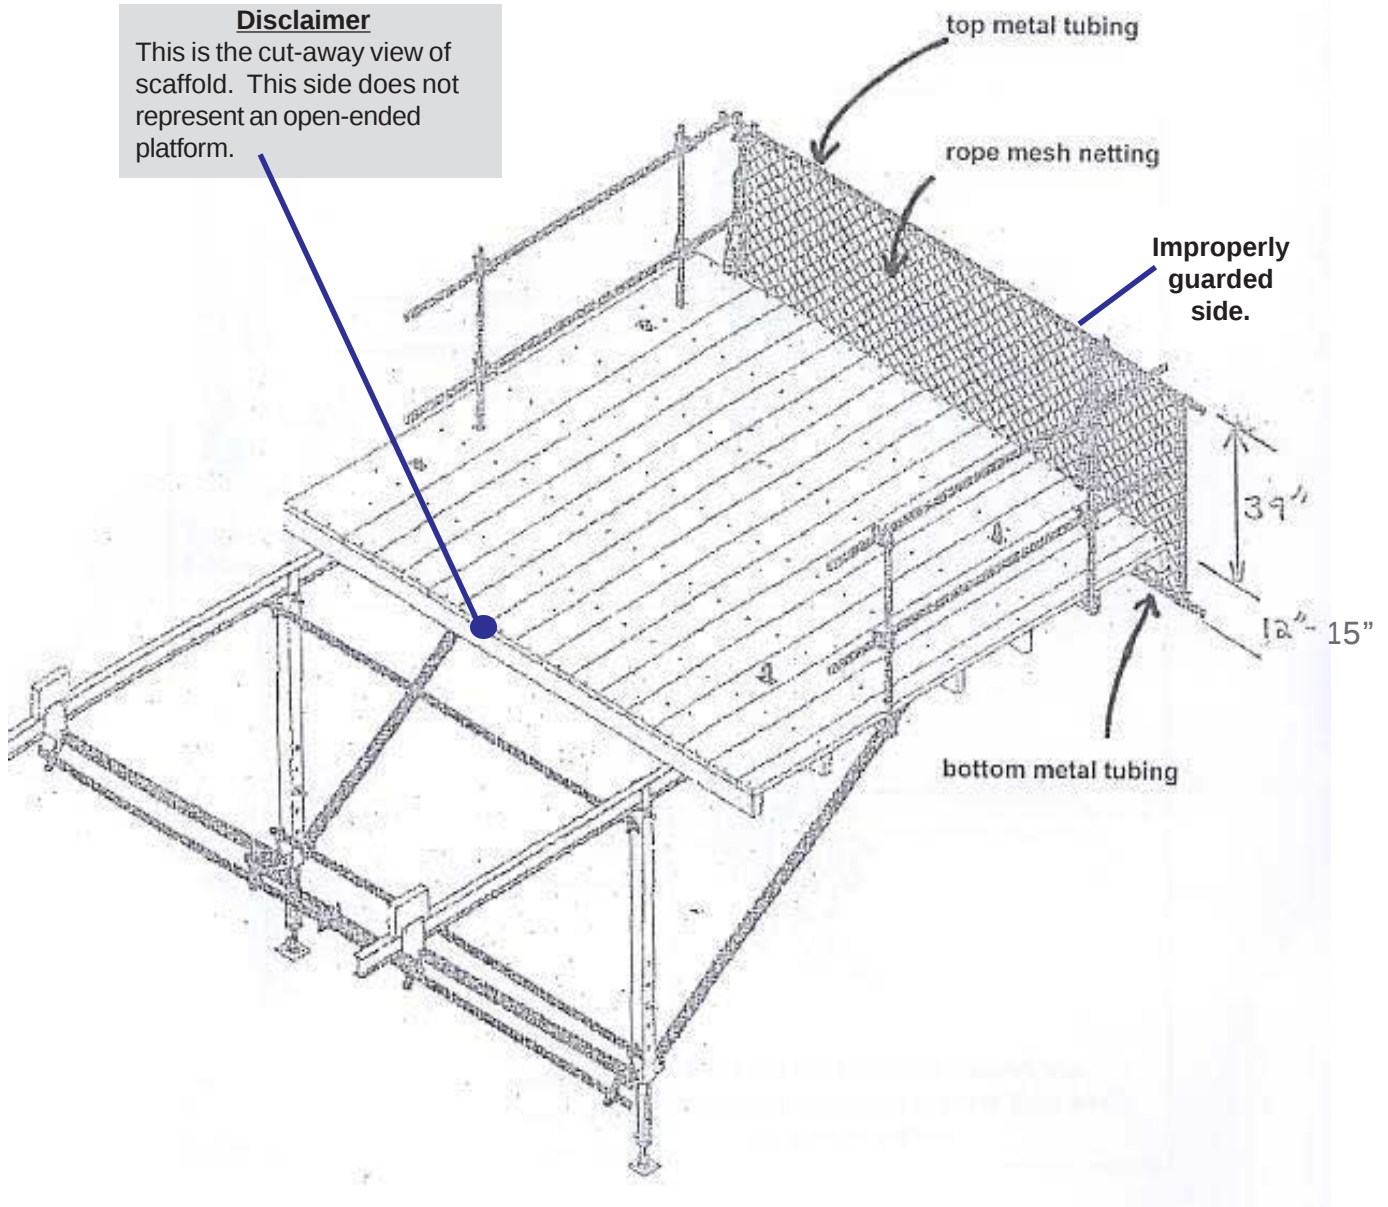
Figure 1

## Cut-Away View of “Stripping Platform” (drawing not to scale)

Recently, an OSHA Area Office inspected a construction site where the high-rise structure was being built using “tunnel forms.” Figure No. 1 is an illustration of the perimeter “netted” guardrail system which the Compliance Officer observed. It consists of mesh rope netting attached to top, bottom, and vertical metal tubing. The guardrail system attaches to the stripping platform, and extends 39 inches above and 12 to 15 inches below the platform

edge. There was, however, a horizontal opening of 7 inches measured from the edge of the platform to the netting. When a tape measure was used to push the netting away from the platform edge, it created an opening of at least 19 inches.

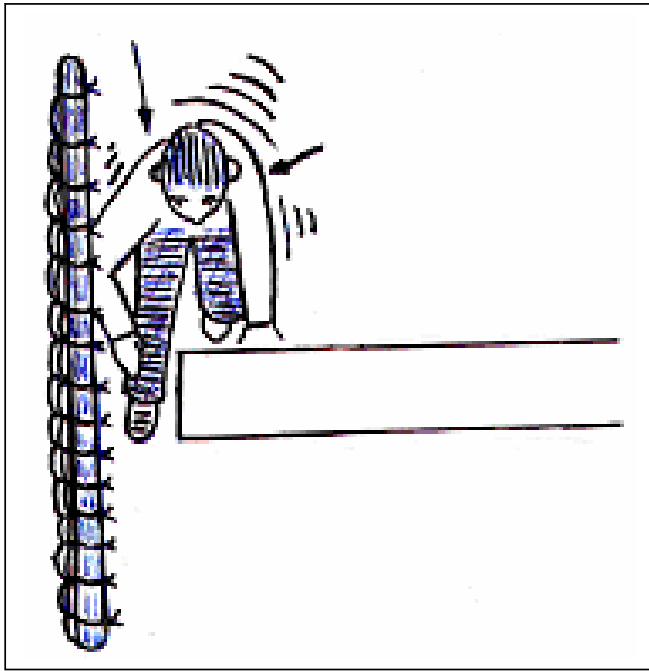
Figure 2-1. Description of the potential to fall - Employee steps into opening

As a result of the inspection, citations were issued. The opening between the platform edge and the netting could expand to more than 19 inches, and allow an average-sized worker to fall through the opening [Figures No.2-1 - 2-4]. Thus, the fall prevention system did not eliminate all fall hazards.

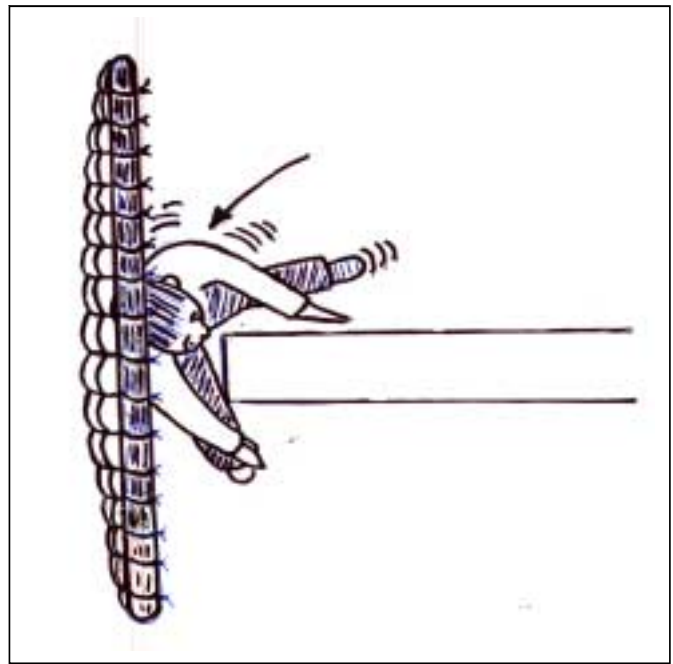
Figure 2-2. Employee loses balance and begins to fall into netting system

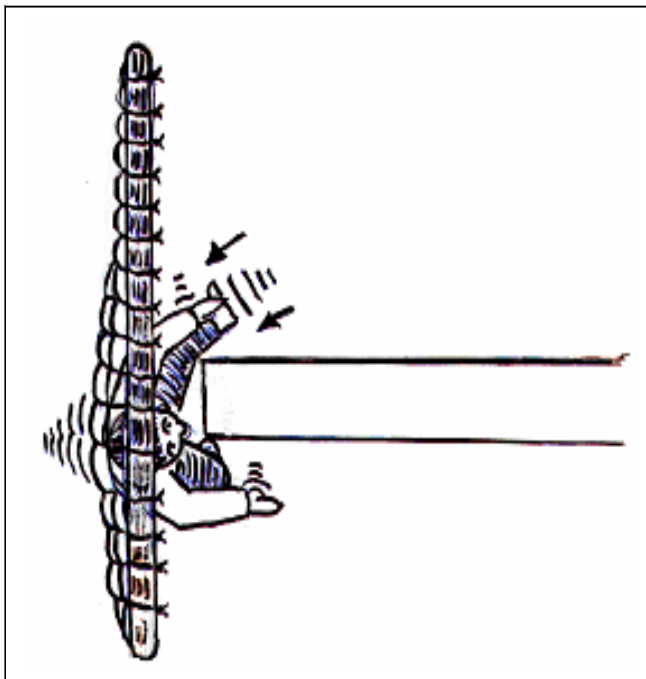
Figure 2-3. Momentum carries employee downward

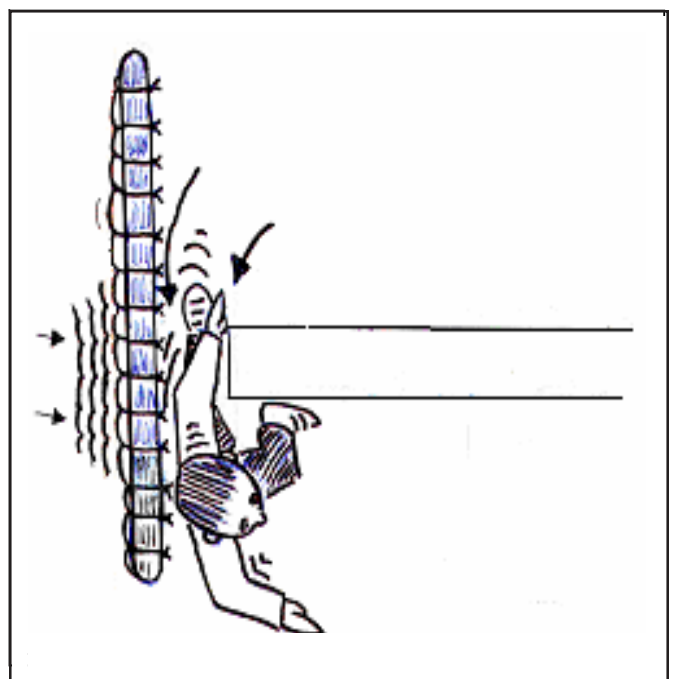
Figure 2-4. Employee clears floor edge and when the net tightens near the bottom rail it would have the tendency to push the employee out of the net

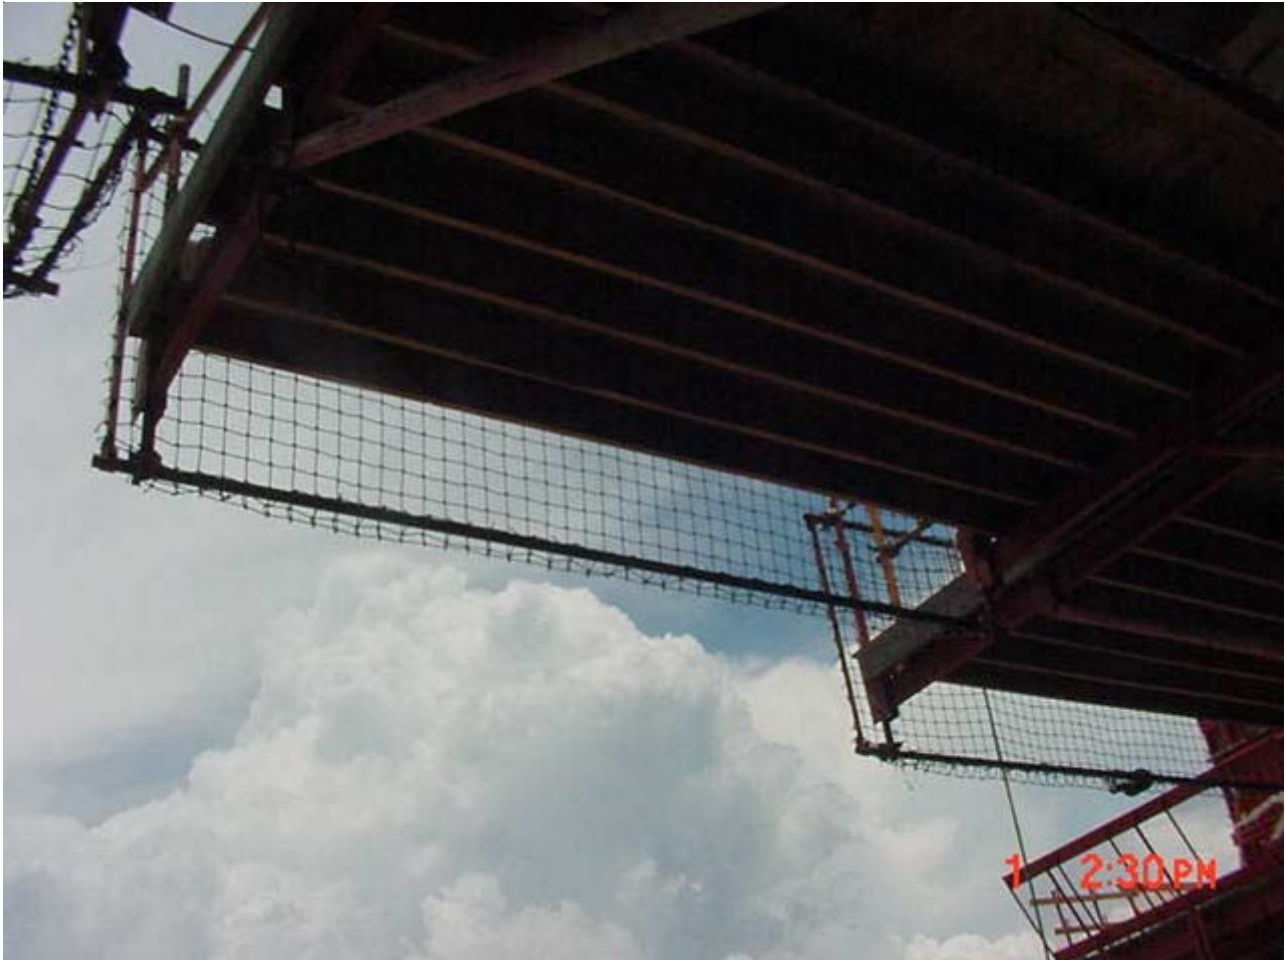
**Underside of Stripping Platform showing mesh guarding.**
