## Farmworker Electrocution

Occupational Safety and Health Administration

### INCIDENT SUMMARY

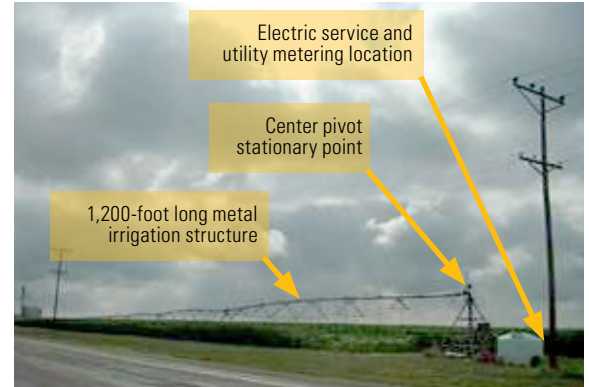
The irrigation system, represented in Figure 1, was not effectively bonded or grounded prior to the lightning strike. The interconnected metal parts were not permanently joined (bonded) to ensure electricity from a lightning strike would travel through the system and into the ground. The grounding system was inadequate because the employer:

- Used heavy duty chain links chained at the center pivot instead of appropriate bonding links;
- Did not install an adequate irrigation structure grounding system (i.e., system ground) including enough grounding rods to prevent damage from lightning;

Figure 1: Typical pivot irrigation system on a 1,200-foot long irrigation machine

- Did not properly ground the energized equipment to the electrical source at the transformer;
- Did not effectively train workers to avoid electrical hazards when walking through the fields.

- Remove irrigation systems from the field when workers are in the area.
- Use qualified electricians to install all electrical systems.
- Bond and ground all metal parts in the irrigation system in accordance with NFPA 70 (National Electrical Code) Article 250 "Grounding and Bonding" and Article 675 "Electrically Driven or Controlled Irrigation Machines." It is important for employers to:

- o Install a grounding system that is continuous and creates a path to ground from all circuits, equipment and enclosures.
  - o Install additional grounding rods when necessary.

- o Connect a bonding conductor from the transformers to the meter pedestal to establish an effective ground fault current path.

- o Install lightning protection to prevent electrical installation failures.
- Re-inspect all electrical installations as needed (for example, after lightning storms) to verify they meet NFPA 70.
- Stay current with equipment manufacturers' safety notices and recalls.
