## Hazards Associated with De-Watering of Pipelines

Safety and Health Information Bulletin  
SHIB 06-21-2004

Advisory Bulletin  
ADB-04-01

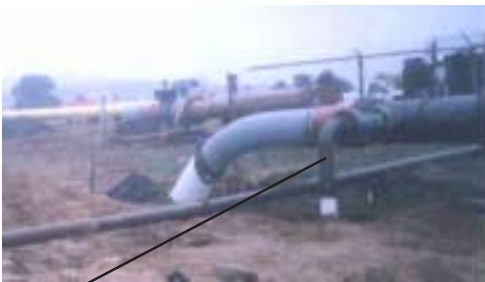
De-watering line      Figure 1

The de-watering process involves connecting a temporary de-watering line (figure 1) to the

main pipeline with mechanical couplers and adequately securing the temporary de-watering line to prevent displacement. A de-watering “pig” (figure 2) is then forced through the main pipeline using

- Study the piping system. During the initial planning stage of a de-watering operation, an engineering analysis of the existing and temporary piping system should be performed to identify the pressure associated with fluids and other forces that could adversely affect the integrity of the pipeline or the stability of the drainage and its components. The employer should design the de-watering system and develop installation techniques based on the expected forces of the particular project. Alternatively, designs and techniques could be developed for a “worst case” scenario that could be applied to all de-watering projects.

- Anchor the de-watering lines. It is accepted industry practice to adequately anchor or secure de-watering piping to prevent movement and separation of the piping. Employers should establish effective anchoring systems based on expected forces and ensure that the systems are used during de-watering projects.

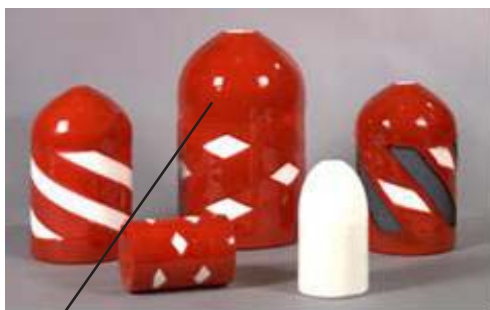
De-watering pig      Figure 2

several hundred pounds pressure of compressed air. As the pig is forced through the pipeline with air pressure, the water remaining in the line from

hydrostatic testing is pushed out of the main pipeline through the temporary de-watering line.

It is possible for the pig to become stalled or stuck in the line. Whether the pig becomes stalled because of air flow around the pig or stuck because of debris inside the pipe or faulty seals, freeing the stuck pig can be problematic. At times, workers will use increased air pressure to attempt to move the pig. While increasing the line pressure is an accepted practice, the safe pressure limits of the pipeline and connections must never be exceeded. If the pressure limits of the main piping or de-watering systems are exceeded, there may be a catastrophic failure of the pipe, or more likely, the pipe connections.

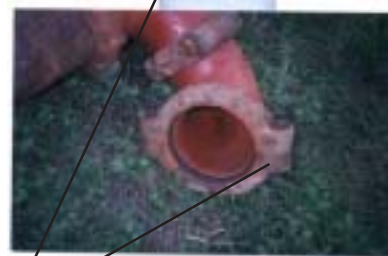
Figure 4

During the de-watering process, significant and sudden variations in pressure often occur within the main pipeline and temporary de-watering line. These variations can be caused by changes in pig velocity as it passes through bends in the pipeline or changes in pig and water velocity due to changes in pipeline elevation. Compressed air escaping around the pig, which can combine with air already present in the main pipeline at high spots in the pipe, can also create a source for stored energy within the main pipeline. These sudden pressure changes produce surges that are transferred from the main pipeline to the temporary de-watering line. This can result in movement of the temporary de-watering line, as the pressures can easily exceed the working pressures and bending capabilities of the temporary de-watering line couplers. The movement of the de-watering line can result in violent failure of the temporary piping system, particularly when the temporary piping is not properly anchored. This situation can be exacerbated when the temporary pipeline suddenly changes direction, when couplers or pipe sections (figures 3, 4 and 5)

Couplers

have worn beyond the specified tolerances established by the manufacturer of the de-watering piping system, or when the entire de-watering manifold is inadequately designed for the stresses that can be imposed while de-watering.

The condition of the couplings, which are used to attach the de-watering pipe to the main gas line and other temporary de-watering pipe sections, likely contributed to one of the accidents that OSHA investigated. In that case, the failure occurred at a pipe coupler that was not within the manufacturer’s established tolerances. With the added pressure of the de-watering process, a damaged or improper coupler could contribute to the separation of temporary pipe sections. It is imperative that all connections and fixtures be in proper working condition. The groove installed on the pipe needs to be conformed to manufacturer specifications and guidelines, be properly fitted, as specified by the engineer who develops the de-watering plan, and chosen for the application.

- Ensure condition of couplings and parts. All couplings and parts of the de-watering system need to be properly selected for their application. The associated piping which the couplings connect is a significant variable in the entire mechanical piping system. The couplings are manufactured in a controlled environment, and variations in the quality of the couplings should be limited. Employers should ensure that couplings are within manufacturer’s tolerances and free of damage that may result in connection failure. A chain is only as strong as its weakest link — in de-watering piping systems, the weakest link frequently is the temporary de-watering pipe connections.

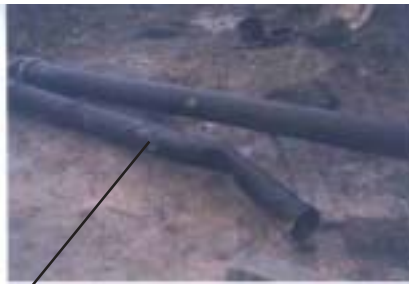
Figure 5

Damaged pipe

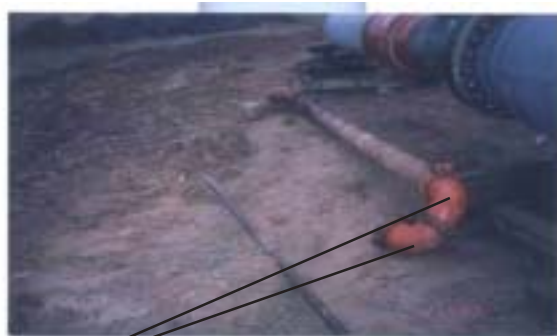
Figure 6

Fittings, such as elbows (figure 6) in piping systems, and other factors also can contribute to pressure variation as the pig passes through the

90° Elbows

piping. Forces associated with those pressure changes can be transferred to temporary piping systems and cause movement and ruptures in connections and piping. Employers should consider the forces involved, and they should design and install anchoring systems to properly restrain or control de-watering piping.
