## Precast Concrete Panels-Hazardous Storage

### Safety and Health Information Bulletin

02-10-2004

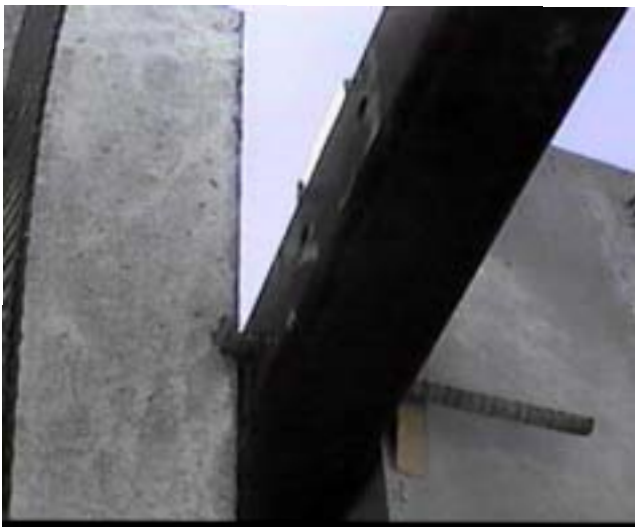
rebar pins that are inserted into the finger rack holes (see figure 1). A single pin can be used on both sides of the finger rack such that the pin is normally positioned to extend out only about 6-7 inches on each side of the square tube. Wooden wedges, of variable widths and thicknesses, are positioned and hammered between the panel and the pins to further secure the panel in an upright position.

The pins used at the site were made of grade 60 billet steel (60-ksi yield strength). Some of the pins used were bent, indicating that they were undersized. The pins did not have any retaining mechanism to prevent the pins from being pushed through the tube holes or for ensuring the pins were inserted the proper distance.

Figure 1. Finger rack with inadequate rebar pin holding panels.  
Also the pin is not properly placed

1. Increase the diameter and/or strength of the rebar pins such that they are less subject to permanent bending during use.
2. Place dunnage under each and every panel in at least two locations (each within two feet of each end of the wall panels) to help prevent twisting motions that could cause the panel to tip and/or cause the wedges to come loose.

6. Design the pins so that they are of a consistent size and shape to ensure proper placement during installation (see figure 3), and that they are also restrained from horizontal displacement once installed. One way of restraining movement would be to install a clevis pin.

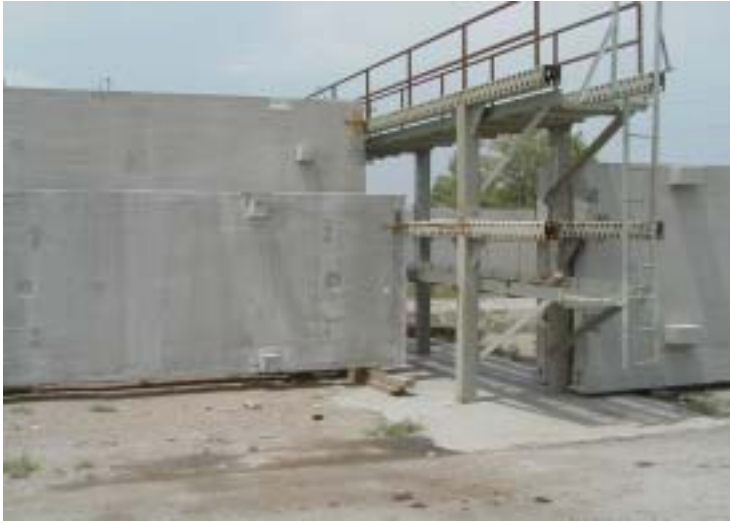
Figure 2. Higher tier finger rack.

4. Secure the wedges to the pin to prevent them from falling out.
5. Include an additional tier rack near the top of the panels to provide additional support (see figure 2).

7. Include additional holes in the rack to minimize the movement of the panels between the pins and minimize the number and sizes of the wedges needed (see figure 2).

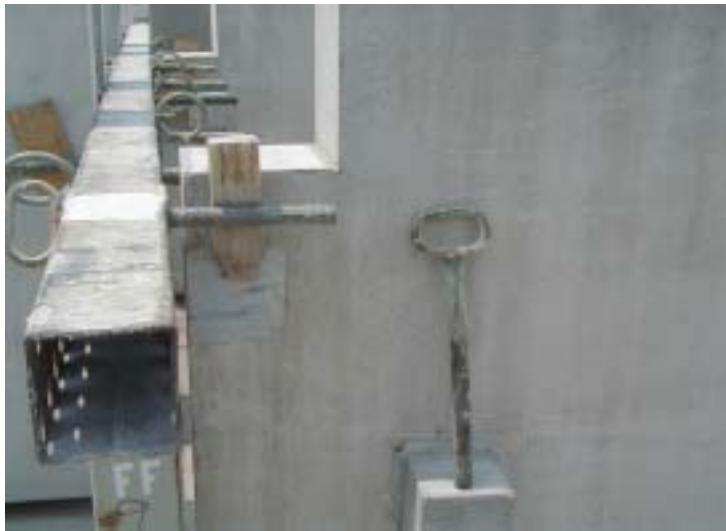
Figure 3. Different types of pins.
